# CASE INCIDENT INVESTIGATION REPORT

## Using Wireshark for Root Cause Analysis and Remediation of Local Area Home Network Disruption

Date of Report: July 22, 2026

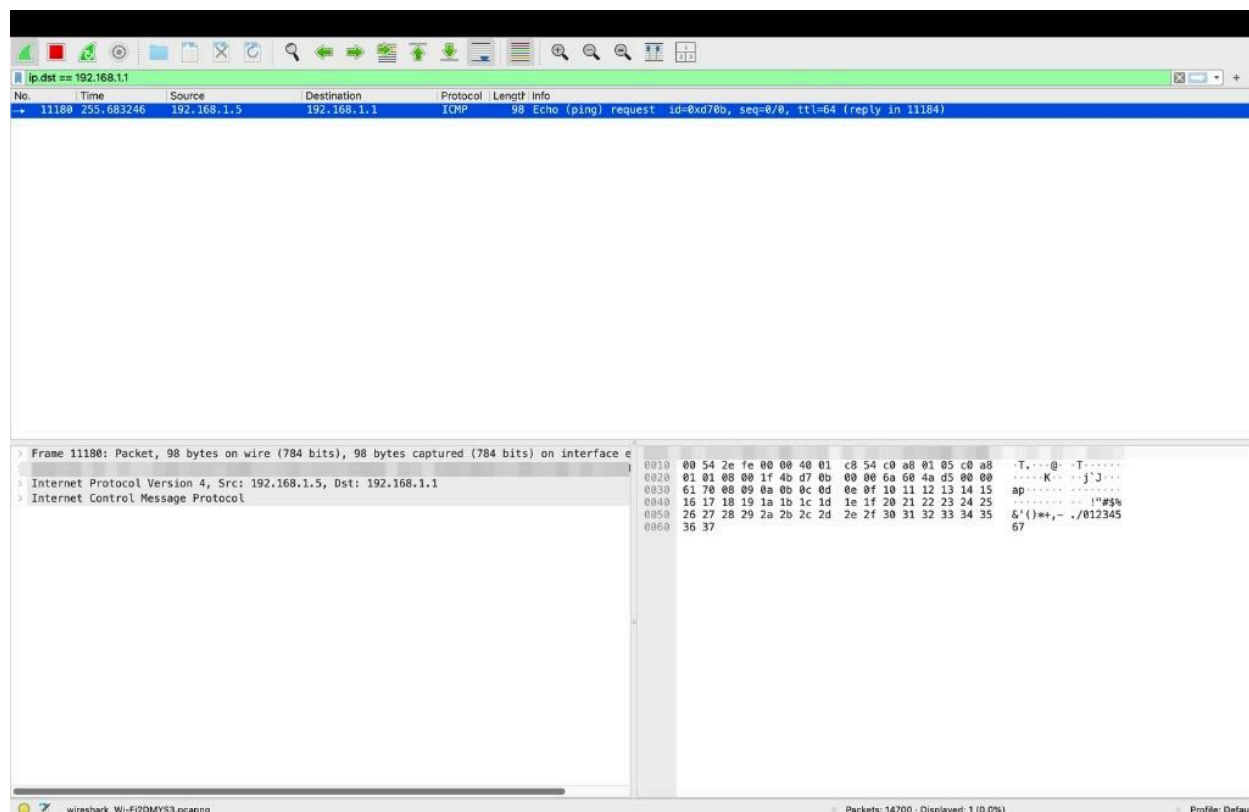
1. **User Symptom:** Multiple client endpoints, including mobile devices and secondary laptops, failed to establish internet connectivity. Endpoints remained stuck in an "Obtaining IP Address" loop or displayed "WiFi icon with exclamation point and indicates no connection"
2. **Hardware Indicator:** The TP-Link repeater in the upper living room displayed a red LED signal, indicating complete loss of wireless backhaul connection to the root gateway.
3. **Local Endpoint Check:** The analyst's workstation verified gateway reachability by issuing ICMP echo requests to the default gateway (`192.168.1.1*`). While basic ping requests succeeded, broader network stability degraded rapidly during simultaneous web requests.

*Figure 1. Initial Gateway Isolation Test showing outbound ICMP Echo (ping) Request from local workstation (192.168.1.5\*) to Default Gateway (192.168.1.1\*).*

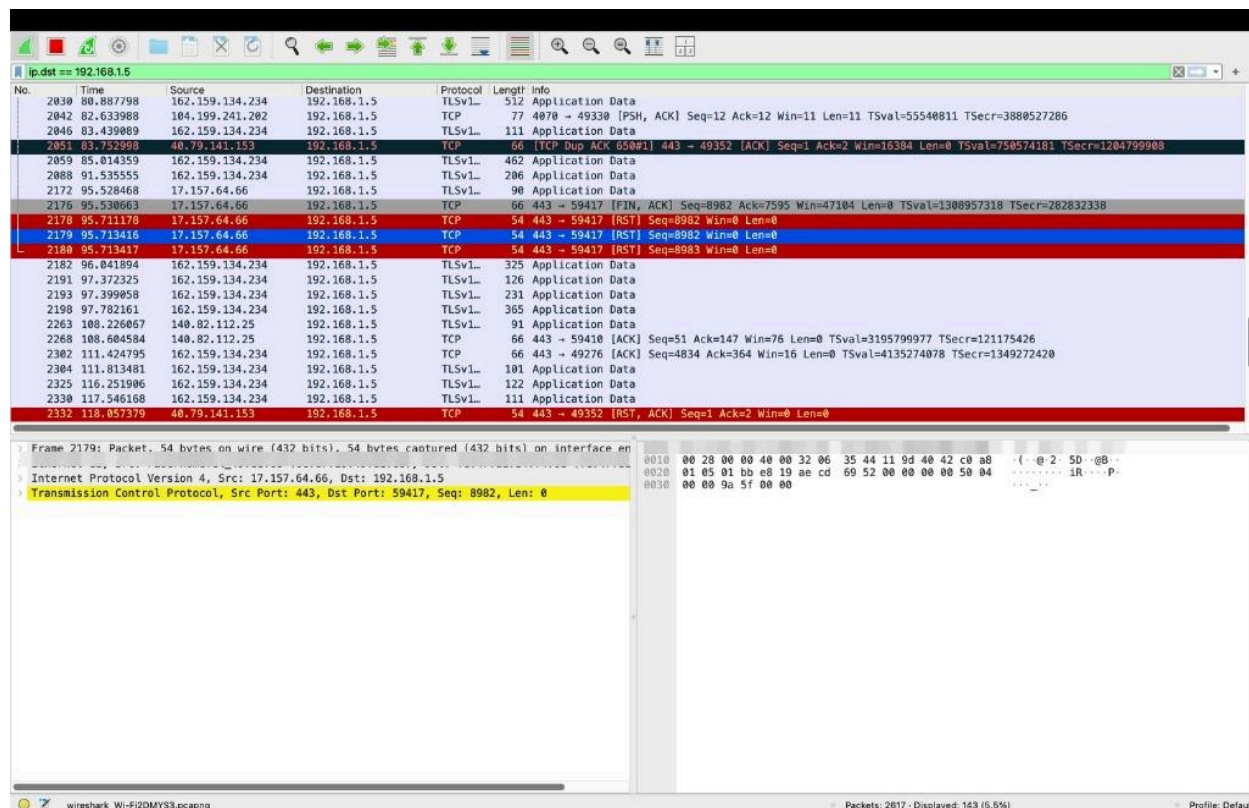
**Observation:** Wireshark logged numerous TCP anomalies, specifically TCP Resets ([RST]) and Duplicate Acknowledgments ([TCP Dup ACK]); multiple external servers (e.g., Apple, Microsoft endpoints) were terminating connections abruptly due to lost state tracking.

Figure 2. Inbound Packet Analysis (`ip.dst == 192.168.1.5`) highlighting TCP Reset packets ([RST]) in red and Duplicate Acknowledgements in dark red.

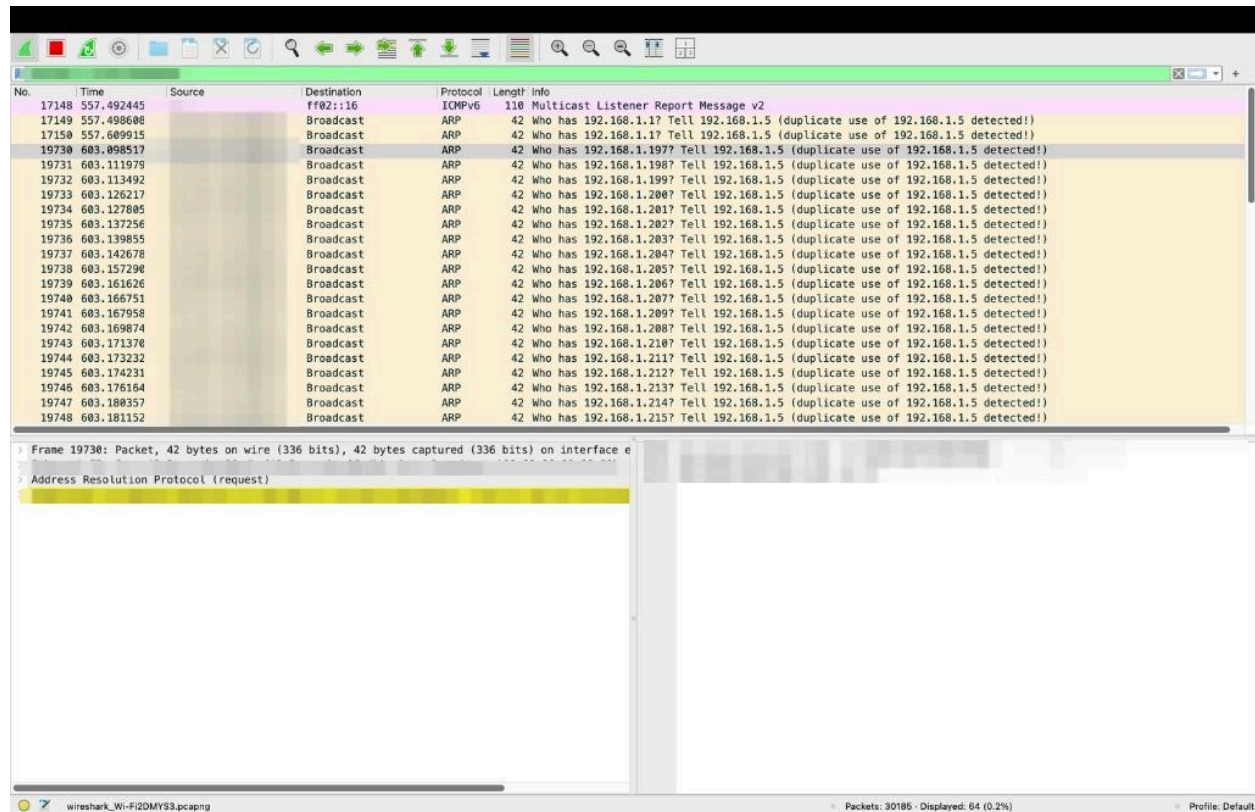
**Observation:** Wireshark recorded a massive volume of broadcast ARP request frames generated by the extender, structured as follows:

Figure 3. Extender MAC Analysis (`eth.addr == 12:3e:cc:ba:96:db`) showing flooded ARP broadcast requests and the yellow duplicate IP warning banner.

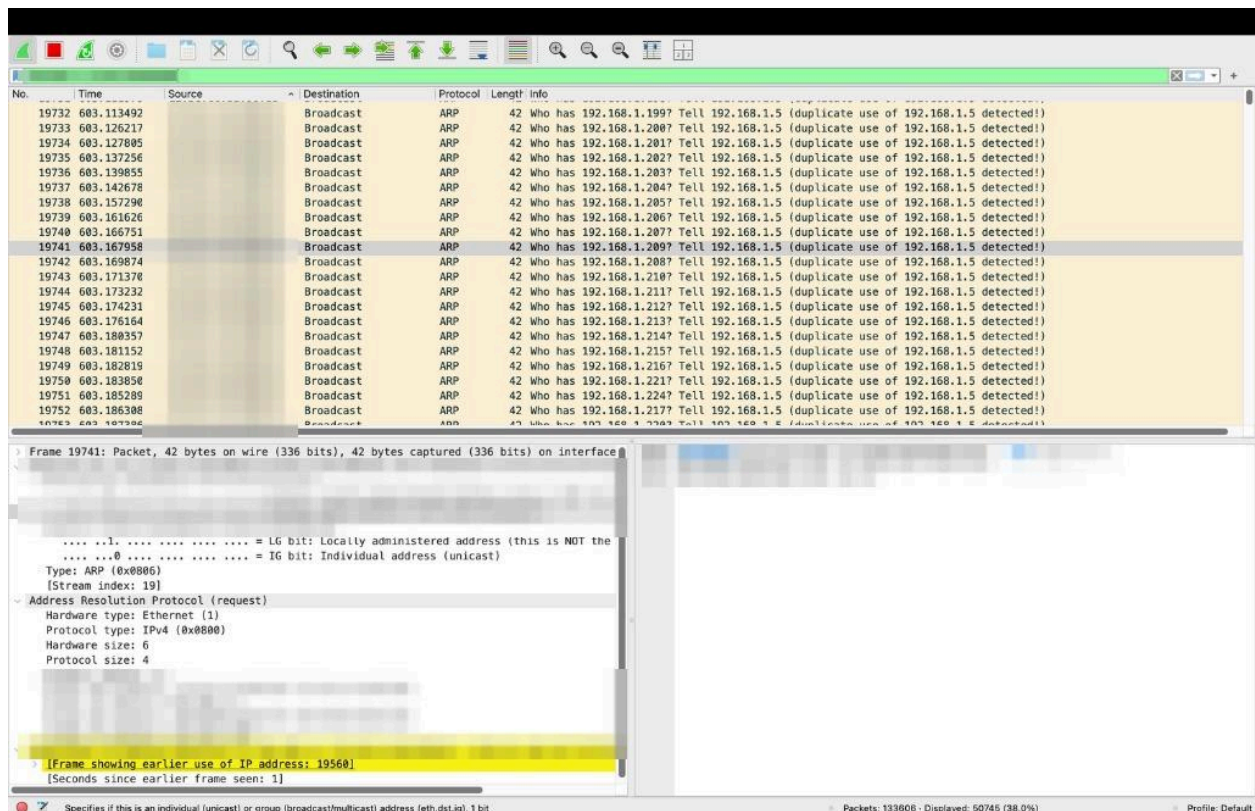
**Observation:** The extender was actively broadcasting to every address in the subnet (.197, .198, .201, etc.), asserting that MAC address 12:3e:cc:ba:96:db owned IP 192.168.1.5\*. Simultaneously, frame 19560 in the capture history showed the analyst's workstation (fe:47:d1:14:f4:6d) claiming the exact same IP address.

*Figure 4. Extended Packet Trace showing persistent Layer 2 broadcast loops generated by the extender prior to reboot.*

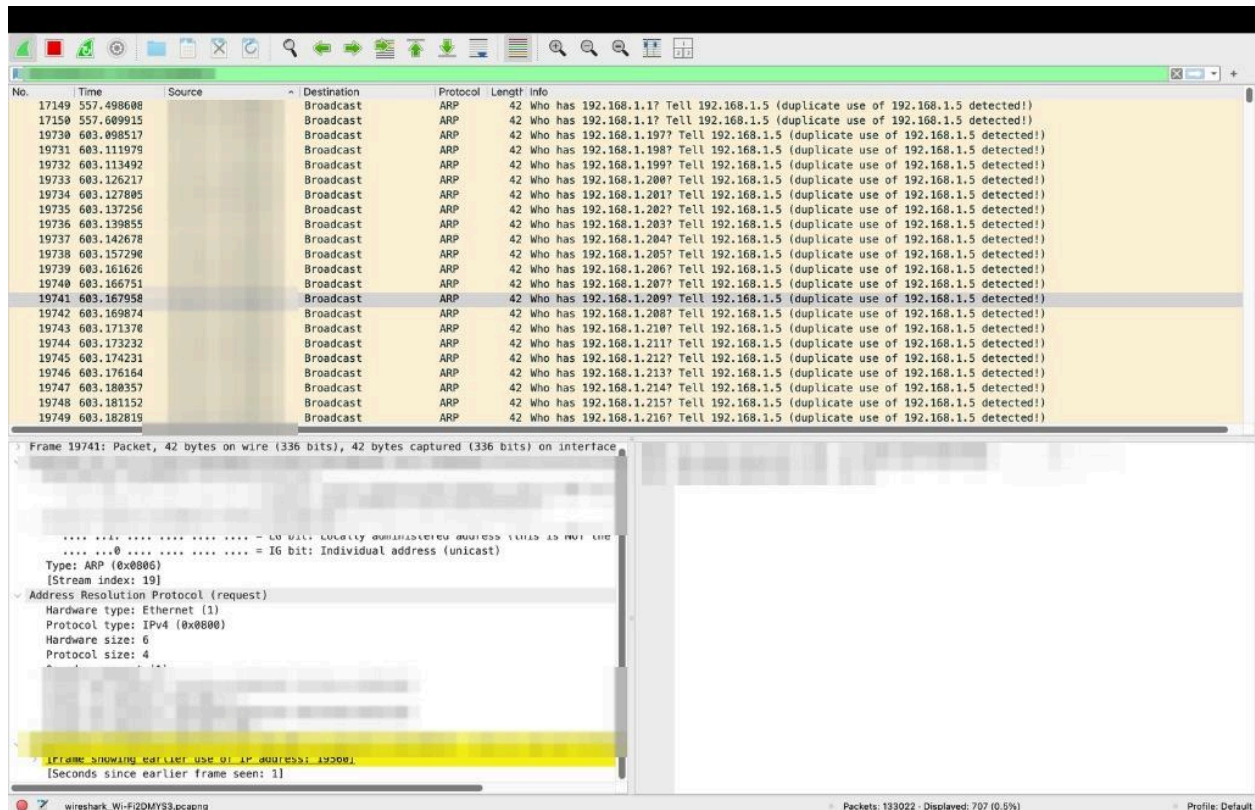
Figure 5. Isolated ARP Source Traffic (arp and eth.src == 12:3e:cc:ba:96:db) displaying continuous broadcast probes across the .1 subnet. Prior to reboot.

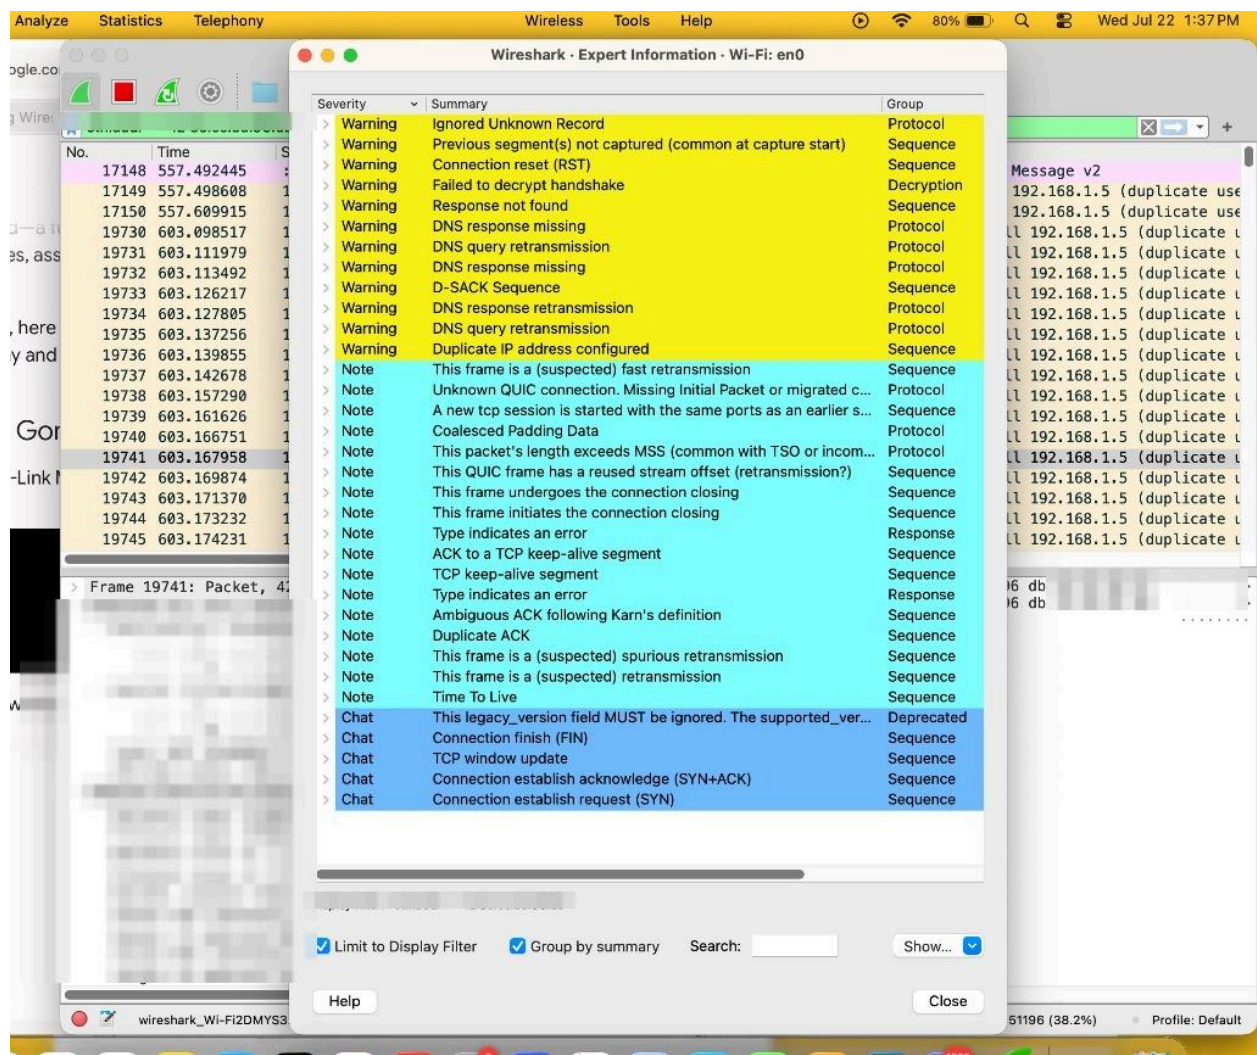
- Severity: Warning
- Group: Sequence
- Protocol: ARP / IPV4
- Summary Text: [Duplicate IP address detected for 192.168.1.5\* (12:3e:cc:ba:96:db) - also in use by fe:47:d1:14:f4:6d (frame 19560)]

- **DNS query retransmission** (DNS requests dropping due to routing ambiguity)
- **DNS response missing** (Gateway responses delivered to incorrect hardware interface)
- **Connection reset (RST)** (Abrupt TCP socket termination)

Figure 6. Pre-Fix Expert Information Window displaying critical warnings, including 'Duplicate IP address configured', dropped DNS queries, and decryption alerts.

Since PLDT gateway's internal DHCP lease table was corrupted with conflicting binding entries, a software-only release was insufficient; a full physical power-cycle sequence was implemented to clear volatile memory on all network nodes.

1. **Complete Power Disconnection:** Unplugged the primary PLDT FiberHome router, the primary room repeater ("Alien") from physical power sockets simultaneously.
2. **Capacitor Discharge Period:** Maintained total power termination for 30 seconds to ensure full memory wipe of internal ARP tables and DHCP binding states (in a nutshell, just wait for 30 seconds once you unplug both the router and the primary repeater.)
3. **Sequential Boot Sequence:**

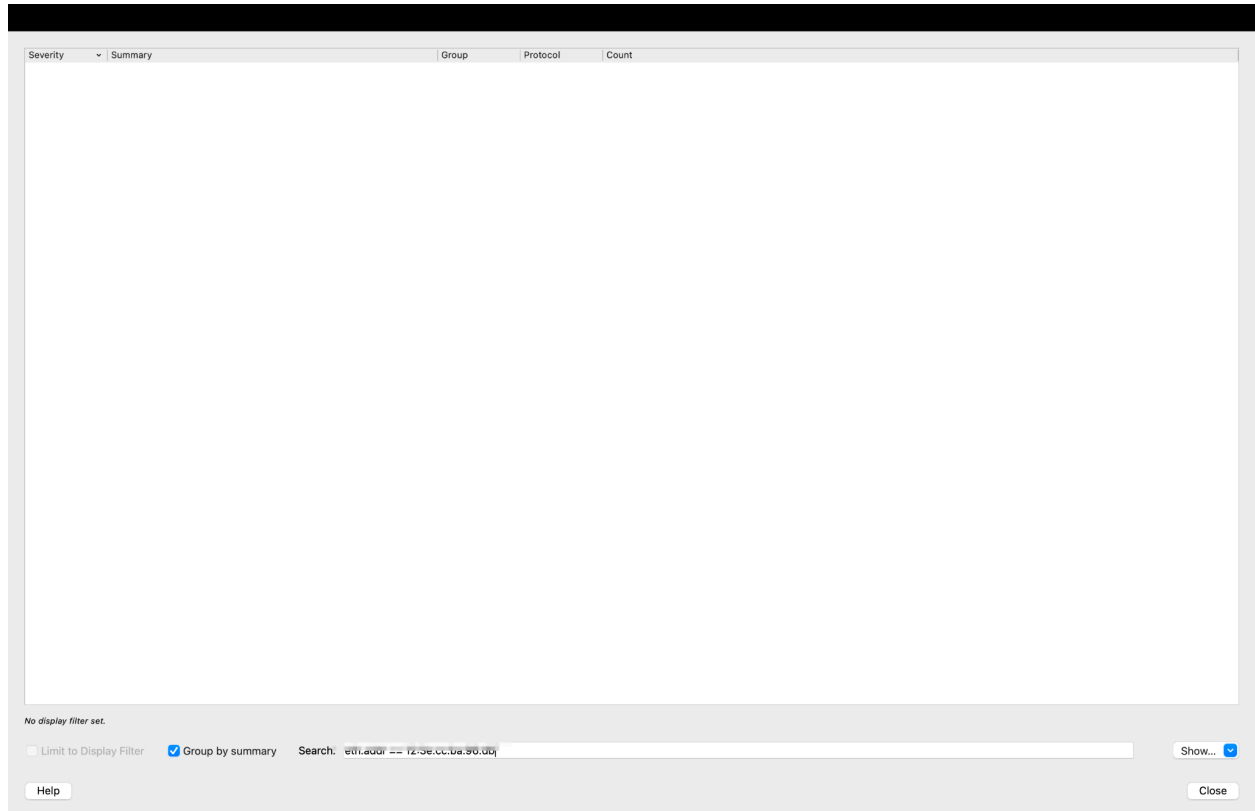
2. **Zero Duplicate IP Warnings:** The yellow warning banners and Expert Info alerts regarding duplicate IP addresses vanished completely.
3. **Protocol Normalization:** Traffic shifted cleanly to standard encrypted web protocols (TLSv1.3, TCP, QUIC) without packet loss.
4. **Hardware Status:** The upper living room extender restored its normal white/blue status LED, confirming active backhaul link; all client endpoints re-established stable internet access immediately.

*Figure 8. Live Post-Fix from Expert Information, specific search on (eth.addr == 12:3e:cc:ba:96:db) it shows nothing, meaning no issues/errors.*

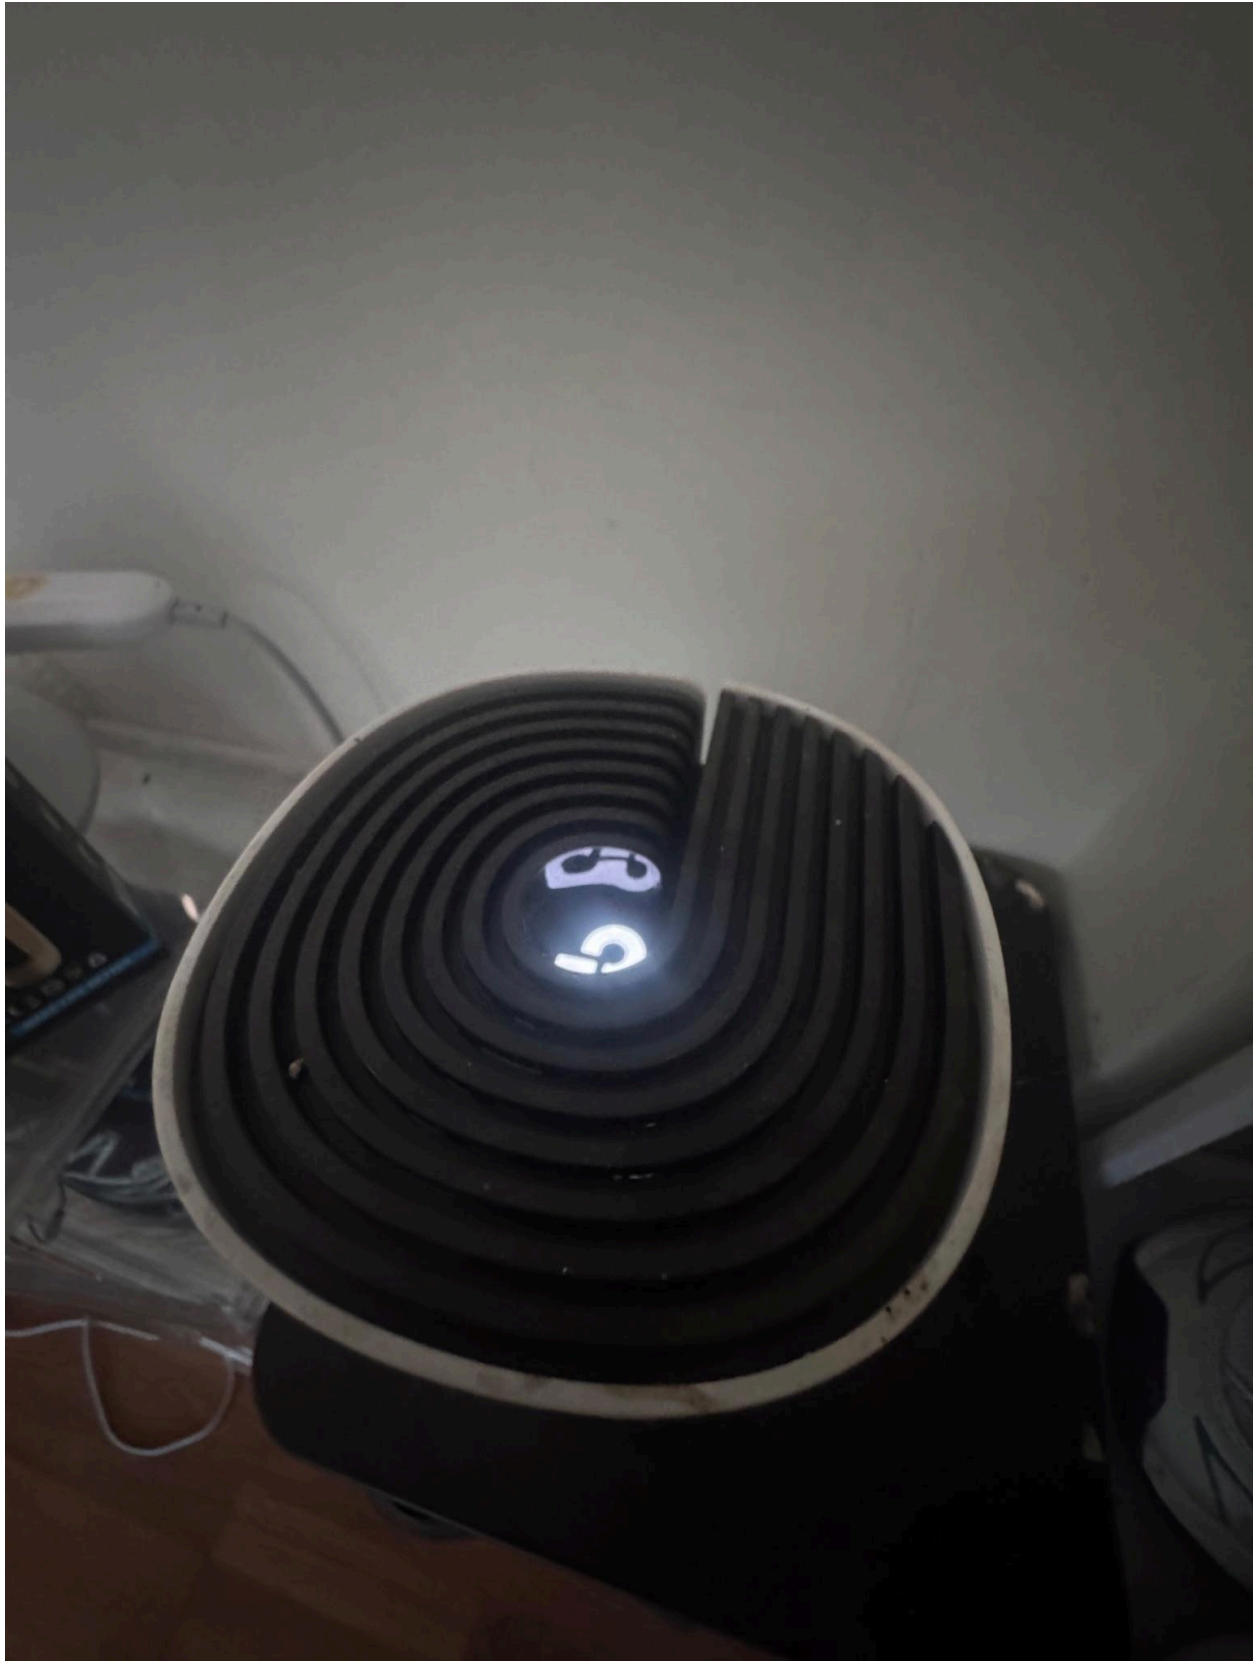
*Figure 9. Topology status; Living Room TP-Link Repeater is clean; no blinking lights.*

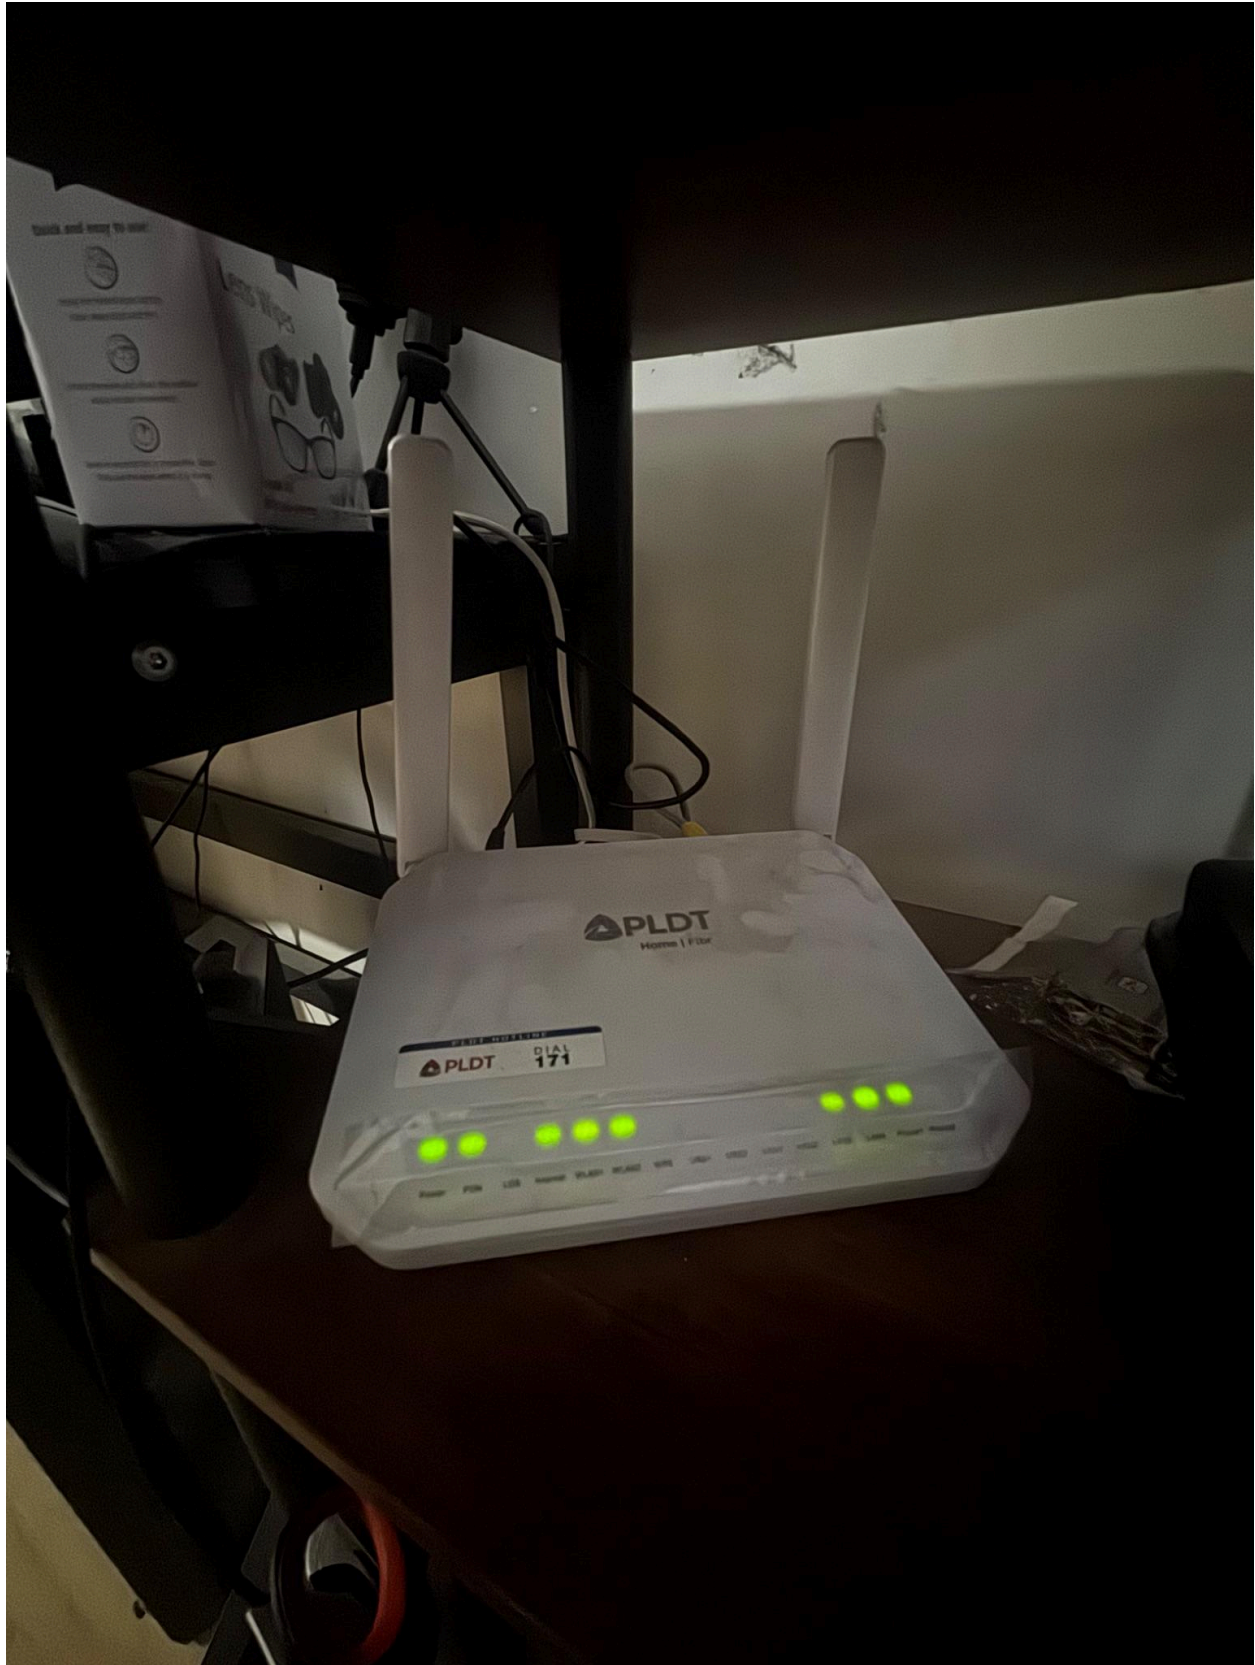
*Figure 10. Topology status; PLDT WiFi Router in Main Room clean; no issues.*

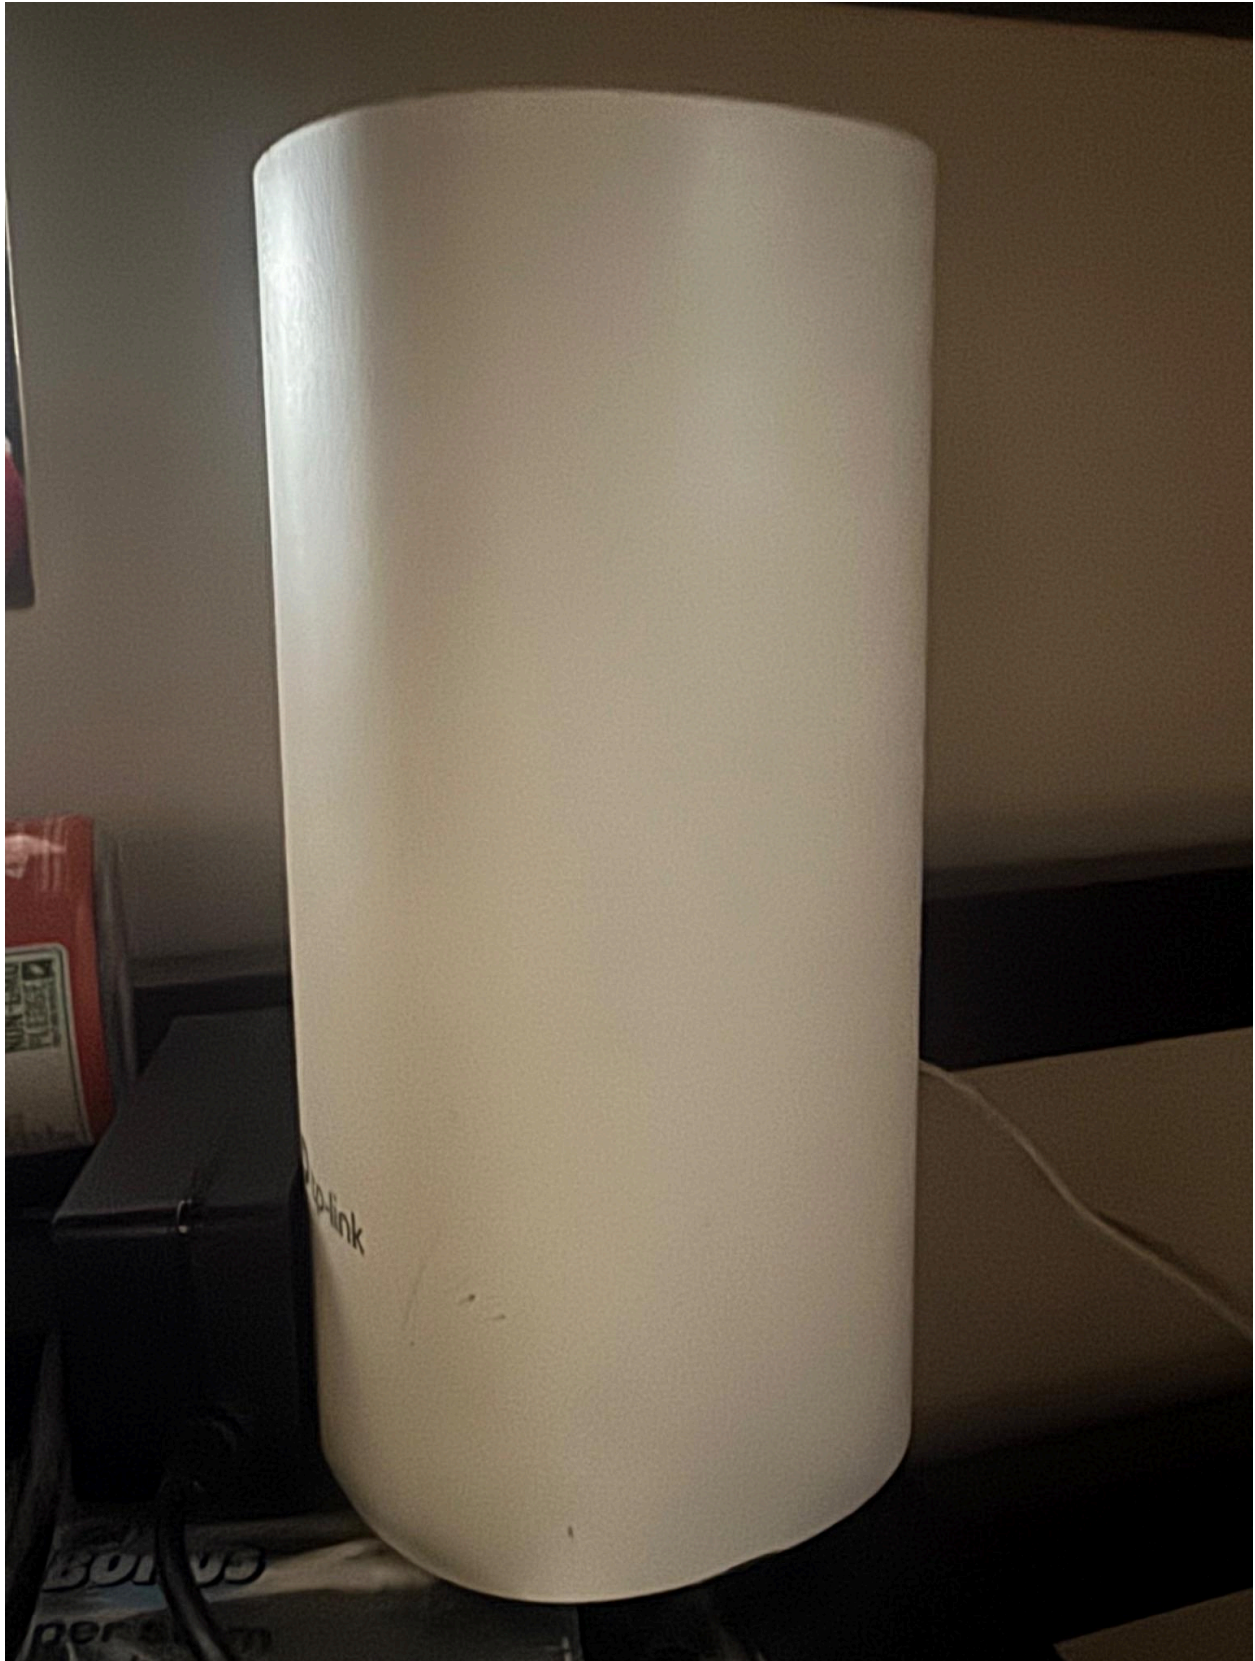
*Figure 11. Topology status; TP-Link Primary WiFi Repeater inside main room clean; no issues*
